Notification No.: 20130320

Description: TBV Intermittent Operation

Hardware: TBV-100 and TBV-101

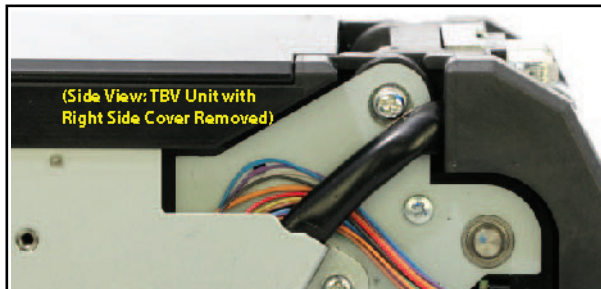
Figure 1

JCM Engineering has received field reports of TBV-100 and TBV-101 Transports exhibiting the following conditions: low acceptance rates, increased bill jams, and/or continuous cycling at power-up. After a detailed investigation, JCM Engineering identified a risk of possible damage to the Sensor (In-Down) PCB Harness during installation of the Right Side Cover on the TBV Unit. The wires can become pinched between the cover and the TBV frame (Figures 1 and 2).

If the TBV Unit is demonstrating the above error conditions, remove the Right Side Cover and examine the Sensor (In-Down) PCB Harness for damaged wires. The Harness should be replaced if damage is visible (replace with Sensor Harness 1 (ID), EDP Part Number 151467). To prevent further damage, use a tie wrap to secure the Sensor (In-Down) PCB Harness to the Sensor (Out-Up) PCB Harness, to move the Harnesses away from the cover mounting screw (Figure 3).
